# The Educational Foundation of Abigail Bailey and Ann Levett

## Grant Application – School House gable end chimney restoration

## Grant Application – Restoring gable end chimney

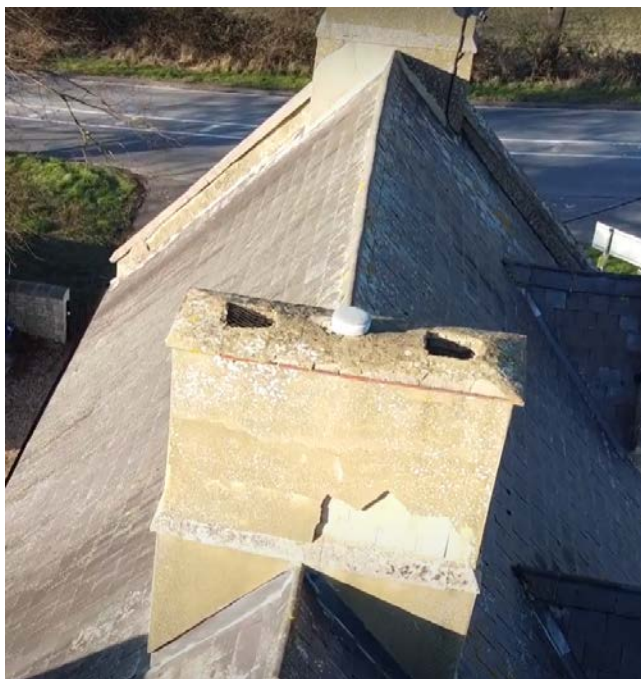
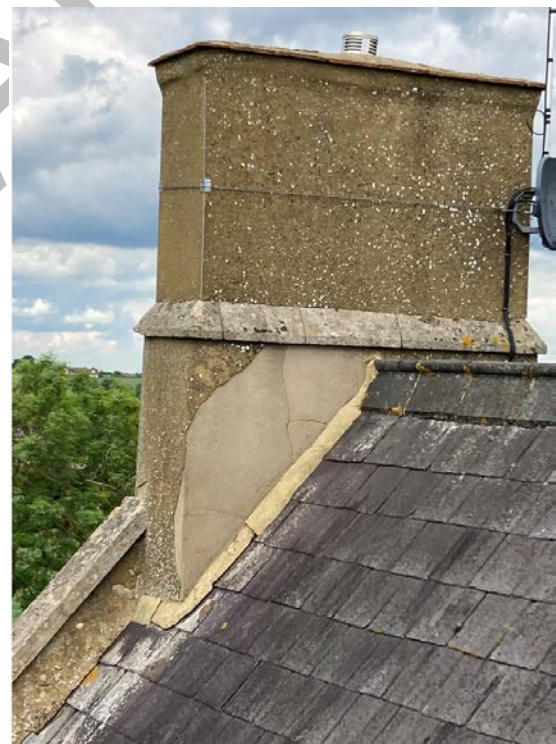
In May 2022 a storm dislodged a large slab of concrete render from the left-hand chimney of School House. Fortunately, it fell to the front of the house and embedded in the lawn away from the front door. Had it fallen to the rear it would have destroyed the tenant's car and injured or killed anyone nearby. The damage was easily visible through a drone inspection, which also showed possible cracks on the gable end chimney.

Drone footage of two chimneys showing loose render on chimney adjacent to Village Hall and cracks to render and flaunching of the gable end chimney. Notice the missing chimney pots and missing corbelling on the damaged chimney, still partially present on the gable chimney.

Ecclesiastical Insurance agreed to the emergency erection of scaffolding to prevent any further masonry falls and to allow the damage to be inspected. It was immediately clear that the render above the plinth had become completely detached and that there was a danger of further falls. It was also clear from this

vantage point that the gable end chimney render was in a very poor condition below the plinth and that the flaunching around the chimney base was failing.

Michael Farrow (local stonemason) inspected the damaged chimney and explained that the wrong render had been applied during roof repairs in 1984. Minutes show that at the time, this was all the Trustees could afford. Concrete render does not allow stone or brickwork to breathe. Water then accumulates behind the render, eventually cracking it and blowing it off as it freezes. He recommended that all render be removed (above and below the plinth) to check the state of the underlying brickwork.

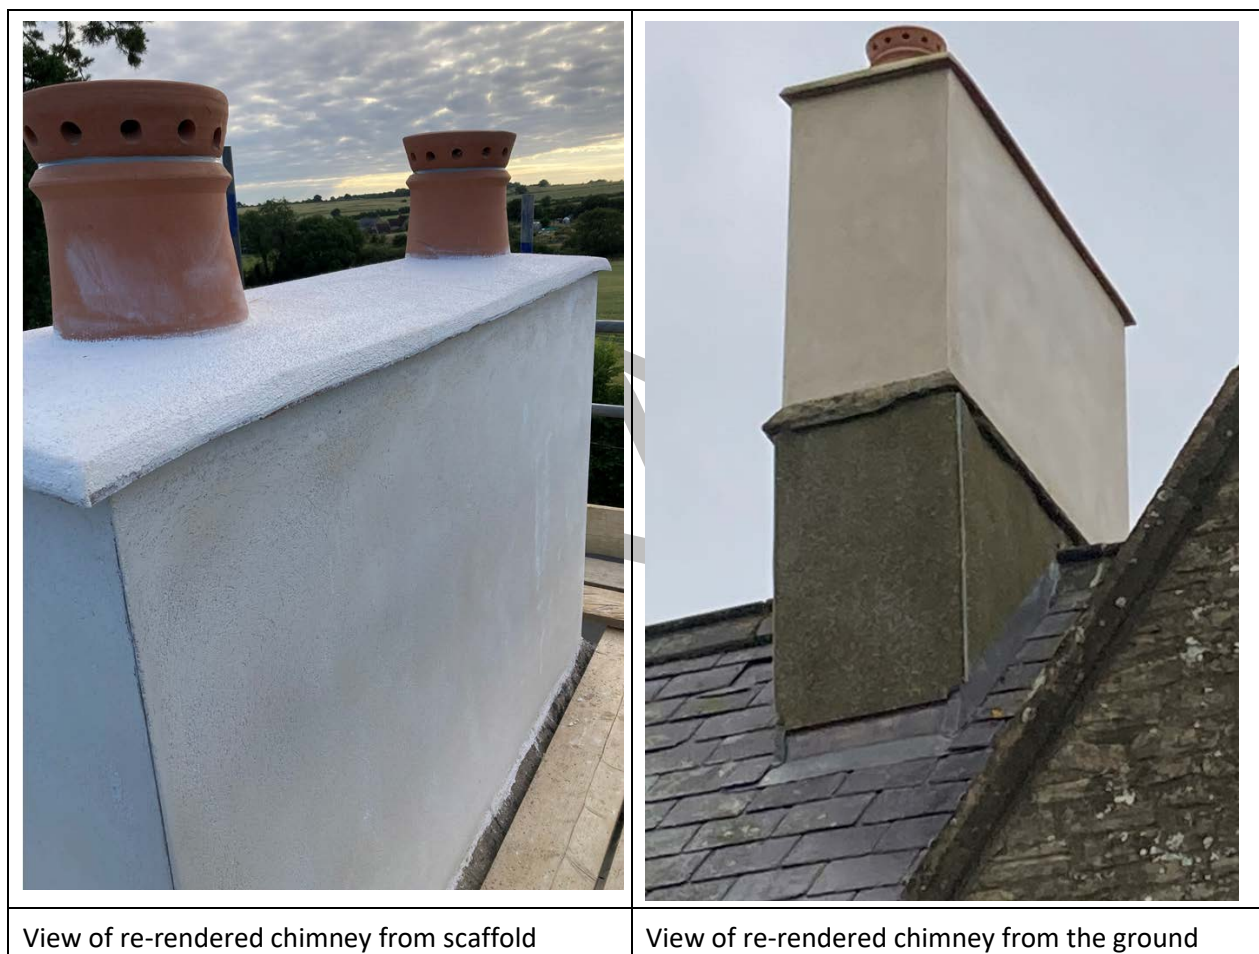
The result is functional and safe but clearly not aesthetically ideal. The Trustees therefore planned a two-phase refurbishment in 2023 and 2024:

However, Ecclesiastical Insurance were only prepared to pay for the re-rendering of the chimney above the plinth in a “like for like” re-instatement (albeit using the correct lime-based render.) Rendering is not Michael’s trade and so we engaged A.J. Thurlow, who works on the rendering restoration of Woburn Abbey. Ecclesiastical Insurance agreed to his quote, and he repaired the render. The total cost of the repairs with scaffolding was **£3,950**. The insurance claim was **£3,697**, deducting our excess and the cost of the new chimney pots which were added to enhance the repair.

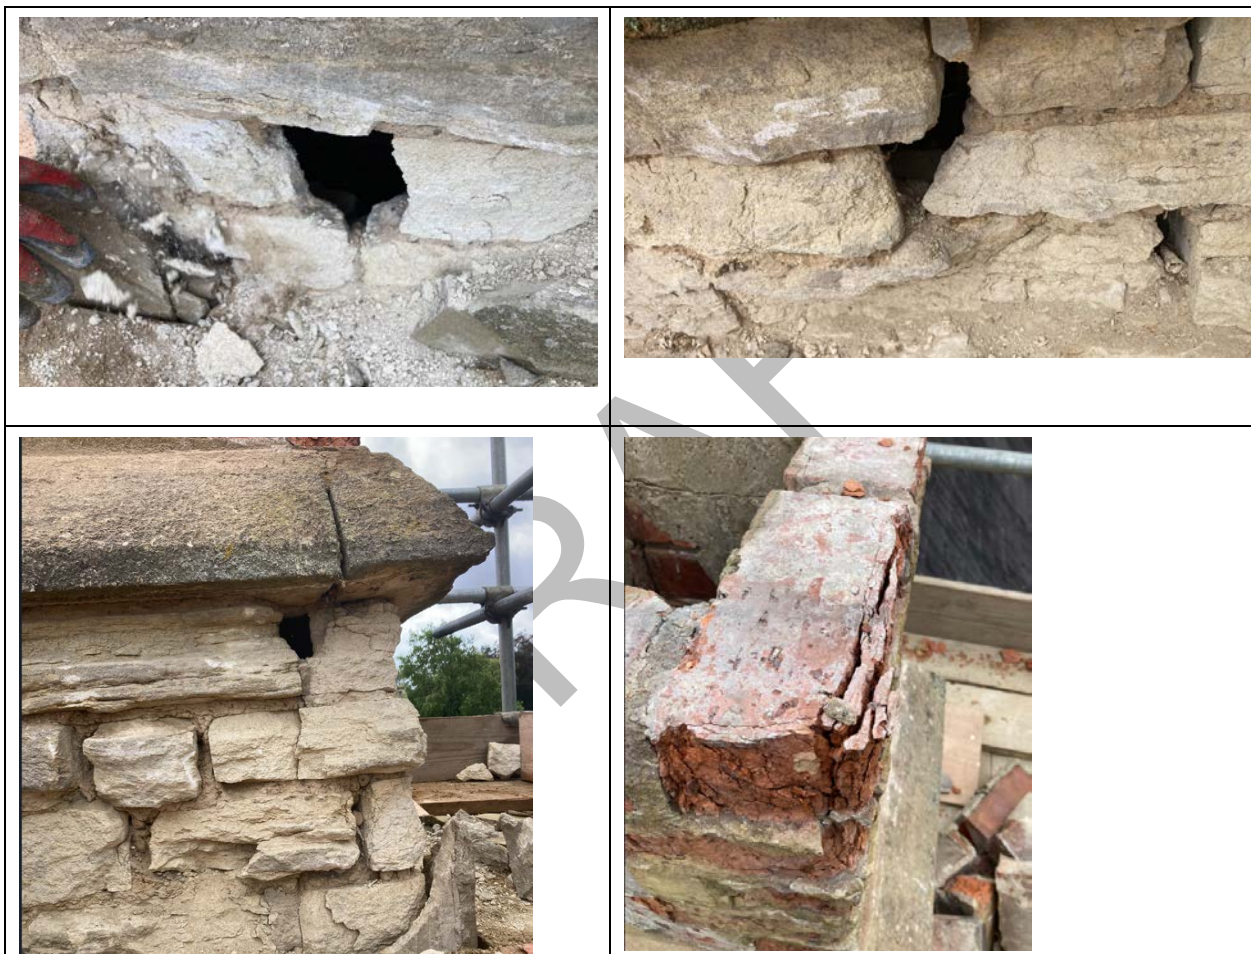
Scaffolding went up in early September 2023 and work started the next week, with the removal of concrete render from above and below the plinth. Within 4 hours, an emergency situation had arisen. It was clear that the render was the only thing holding the chimney together. Water had split the bricks and dissolved the stonework, leaving the mass of the chimney perched on stonework less than 25mm thick. Movement could be detected.

Holes and cracks in eroded stonework and shattered brickwork

Michael Farrow was able to survey the damage. He found that the stone was equally damaged below the ridge line, particularly on the gable end beneath what remained of the concrete render. Demolition of the chimney to slate level and the gable end to below the render line would be needed. The top coping stones on both sides of the chimney were also split where water had penetrated.

The immediate demolition of the chimney down to ridge level was ordered, to make the building safe.

As the chimney is functionally redundant it could technically have been removed and the roof re-slatted. However, this would have been completely out of keeping with the Victorian design. Michael recommended rebuilding the gable in local stone, replacing the split copings and restoring the chimney to its original 1864 design. Chimneys in use often need repairs and their design can be compromised over time as cheaper materials are used and expensive features are removed. By the time of the last repair in

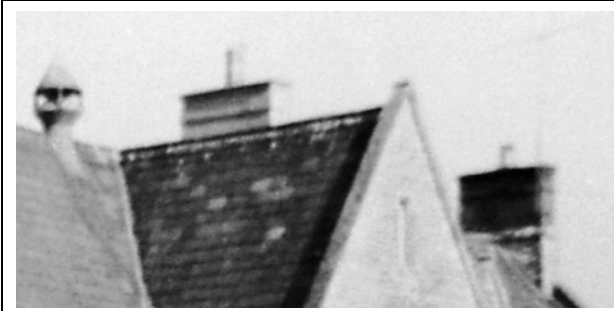
1950s photograph showing poor chimney pot replacement

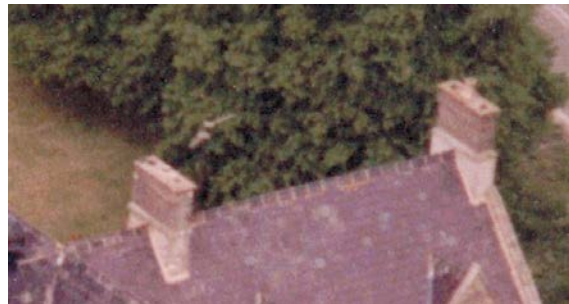
1984, the chimney pots had already gone, and the 1984 repair removed the corbelling at the top replacing it with clay tiles.

1983 photograph taken before corbels were removed and concrete render applied.

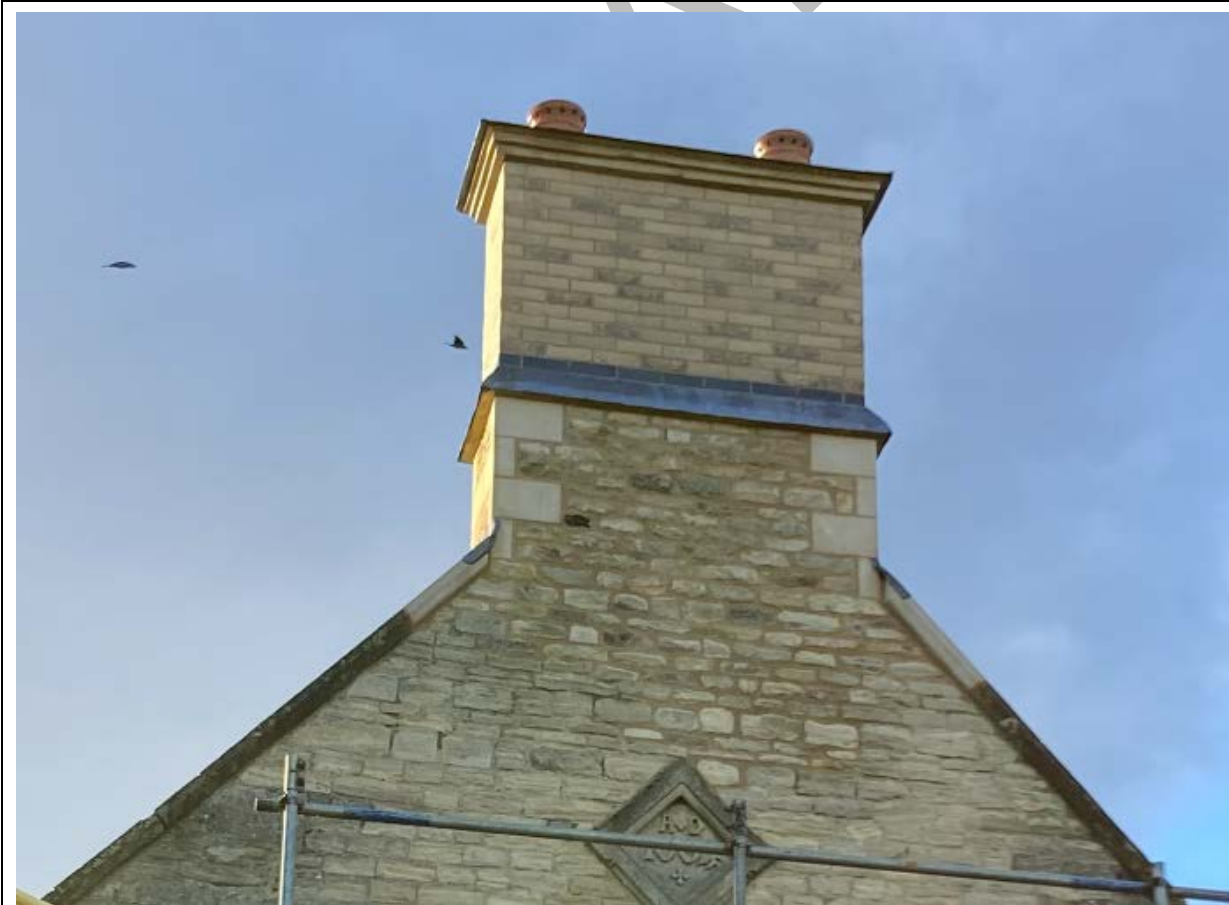
The result is a triumph of craftsmanship, clearly an enhancement to the property and street scene.

Completed restoration
