Educational Foundation Property Strategy 2023-2033

1. Summary

This document reviews the current state of Foundation properties and maps out the maintenance and development challenges that the Foundation faces over the next 10 years.

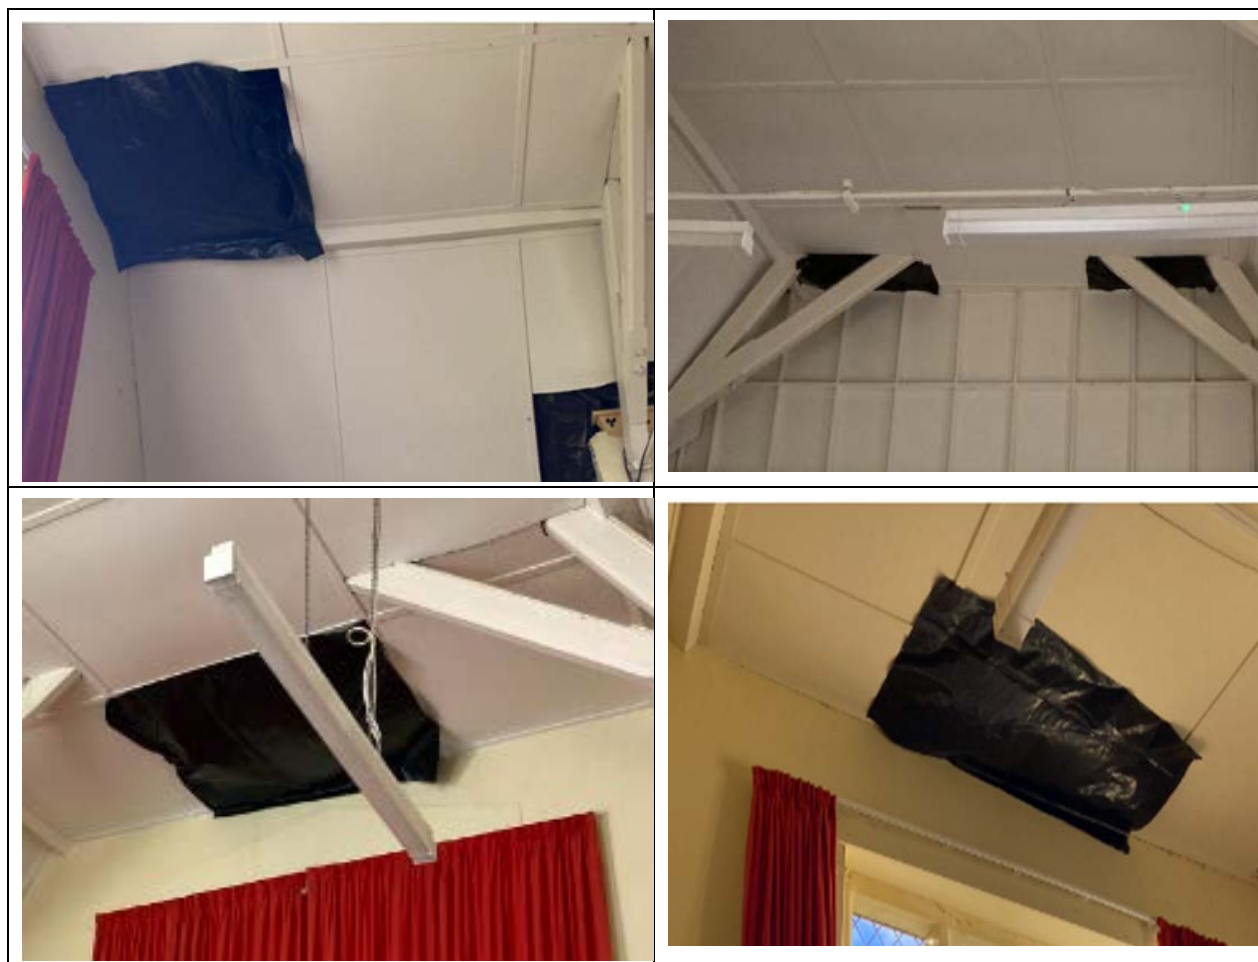
In 2021 the cluster fly infestation became intolerable for hirers. Attempts to control them by the caretakers had failed. Six holes were cut into the ceiling panels to allow for a thorough professional fumigation. Cutting these holes was a dangerous job using ladders over 18ft (5.5 metres) high, but was urgent.

In October 2023, cluster flies returned, having been displaced from School House during the chimney renovation works. The black plastic had to be ripped down to allow a further fumigation. With no safe way of replacing the plastic, the remains have been pushed back into place to block the holes as best as possible.

Figure 2 - Holes in Village Hall ceiling

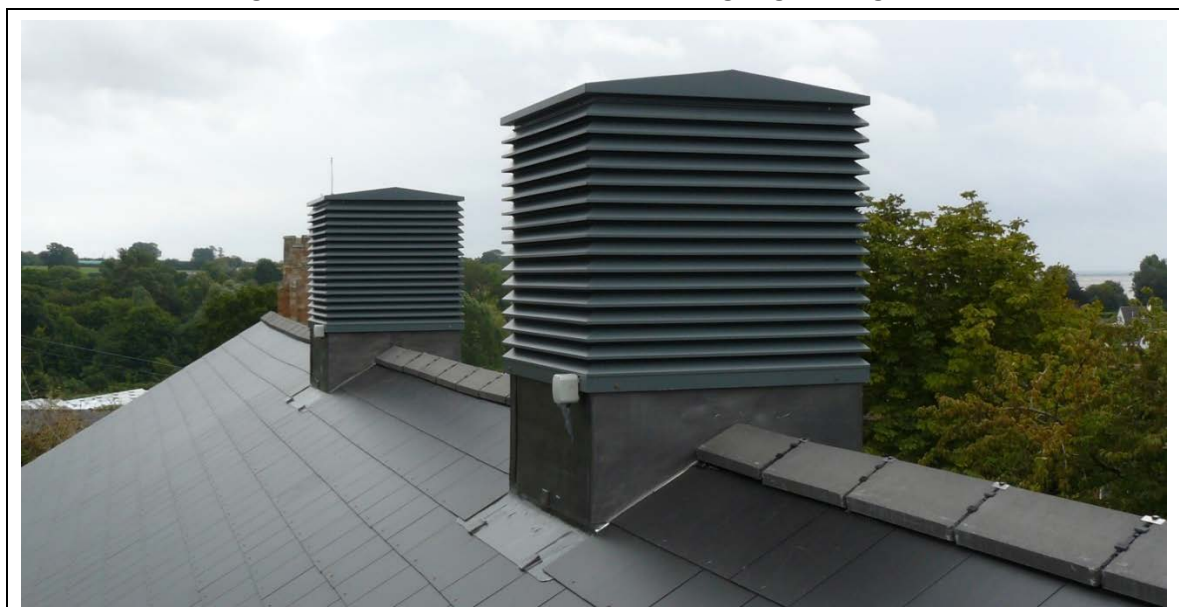
1. Installing ventilation fans into the gable ends. These would be controlled by a sensor, only operating as required, but there would be some associated noise and ongoing running and maintenance costs.
2. Installing ventilation turrets in the ridgeline. These use the wind to draw stale air from the building, replacing it with fresh air. The internal shutters are controlled by a sensor which detects when the air needs refreshing. These units are silent and have no ongoing running cost.

Figure 4 - Passive ventilation using turrets on Lymestone Village Hall

There is a historical precedent for the turret solution. The coke stove chimneys were part of the original design from 1864 and were only removed in 1984. The building has had turrets for 75% of its life. Re-instating them using the turrets shown in figure 4 would not detract from the setting.

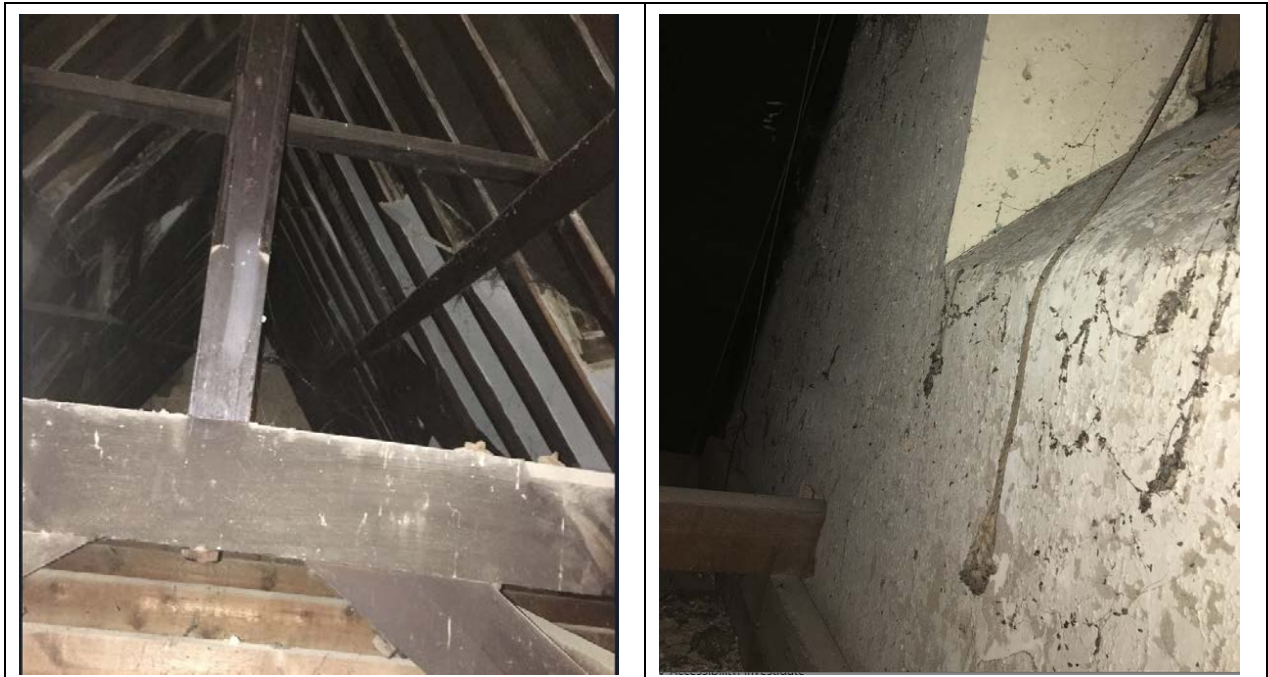
The holes cut into the ceiling for fumigation have allowed the roof space to be surveyed. It was found that there is a traditional vaulted ceiling above the false fibreboard ceiling. It appears that lath and plaster was originally installed between the rafters. This has clearly deteriorated badly leaving the sarking felt visible in many places. It is not surprising that cluster flies can find a way in, and there are many cracks in which they can roost for the winter. The false ceiling is suspended from new softwood joists, with supporting purlins set into wall pockets on the gable ends. The plasterwork above the ceiling on the gable ends is in a very poor state as shown in figure 5.

Figure 5 - Showing vaulted roof space and deteriorating plaster on gable end

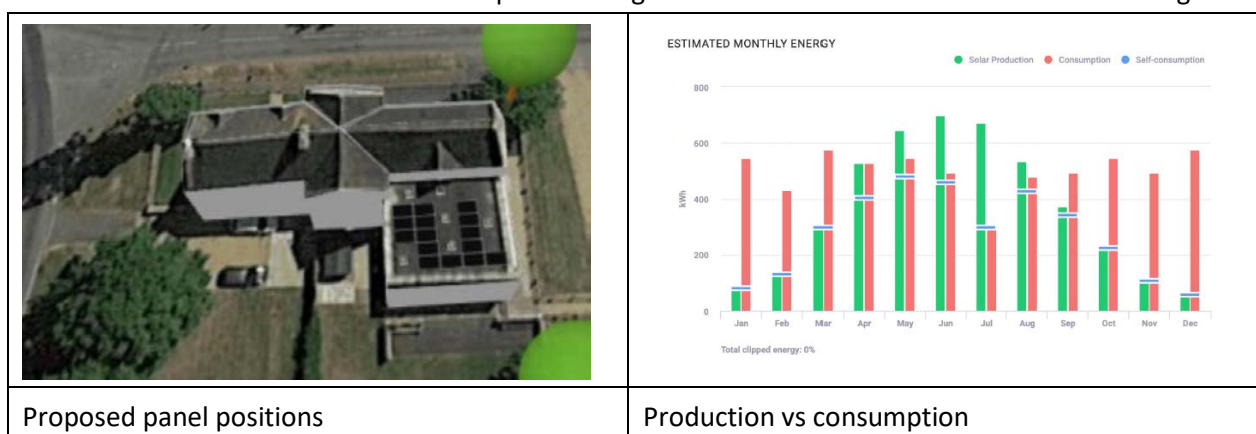
Solar panels: To power a lower carbon solution, the installation of solar panels has been explored with a supplier of 3-phase commercial installations. They have recommended the installation of 15 panels on the extension roof with a generation capacity of 6kW and a 9.2kWh battery. The cost of this installation would be of the order of £25,000, including scaffolding and electrical modifications. A full structural survey would be needed as the panels need to be mounted on weighted frames to resist wind pressure. Fixing down into a flat roof is not recommended as it is impossible to guarantee that the roof would remain watertight.

Figure 7 - Solar proposal

Modelling of solar generation shows that we could generate around 4,630 units of electricity (4,630 kWh) from these solar panels in year 1 (with a 0.5% reduction in efficiency each year). Even before the installation of electric heat pumps for the main Hall, our annual consumption is 6,600 units (averaging 18 units a day). Most of this consumption is in the late afternoon or evening hours, whereas the generation is focused during the daytime. On a bright day, most of the generation would be exported as the 9.2kWh (9.2 units)

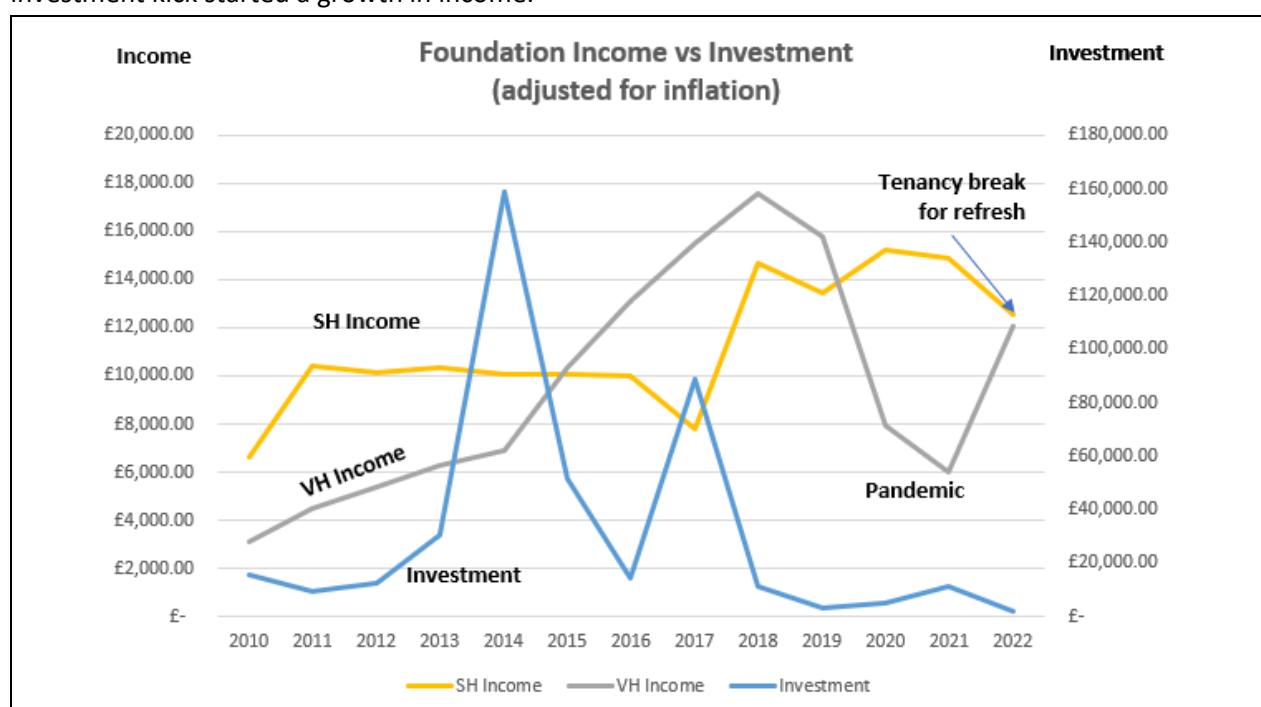
The benefit of the £413,000 investment since 2010 is very clear as shown in figure 11. Each major investment kick started a growth in income.

Figure 11 - Impact of investment on income
